Our Reference: 19216:NB531

RE: LEVEL 1 EARTHWORKS INSPECTION AND TESTING
TRIJENA – STAGES 4 (MICKLEHAM)

TRIJENA STAGE 4
ROAD & DRAINAGE DETAIL PLAN
HUME CITY COUNCIL
PGG (MICKLEHAM) PTY LTD

COMPACTION ASSESSMENT

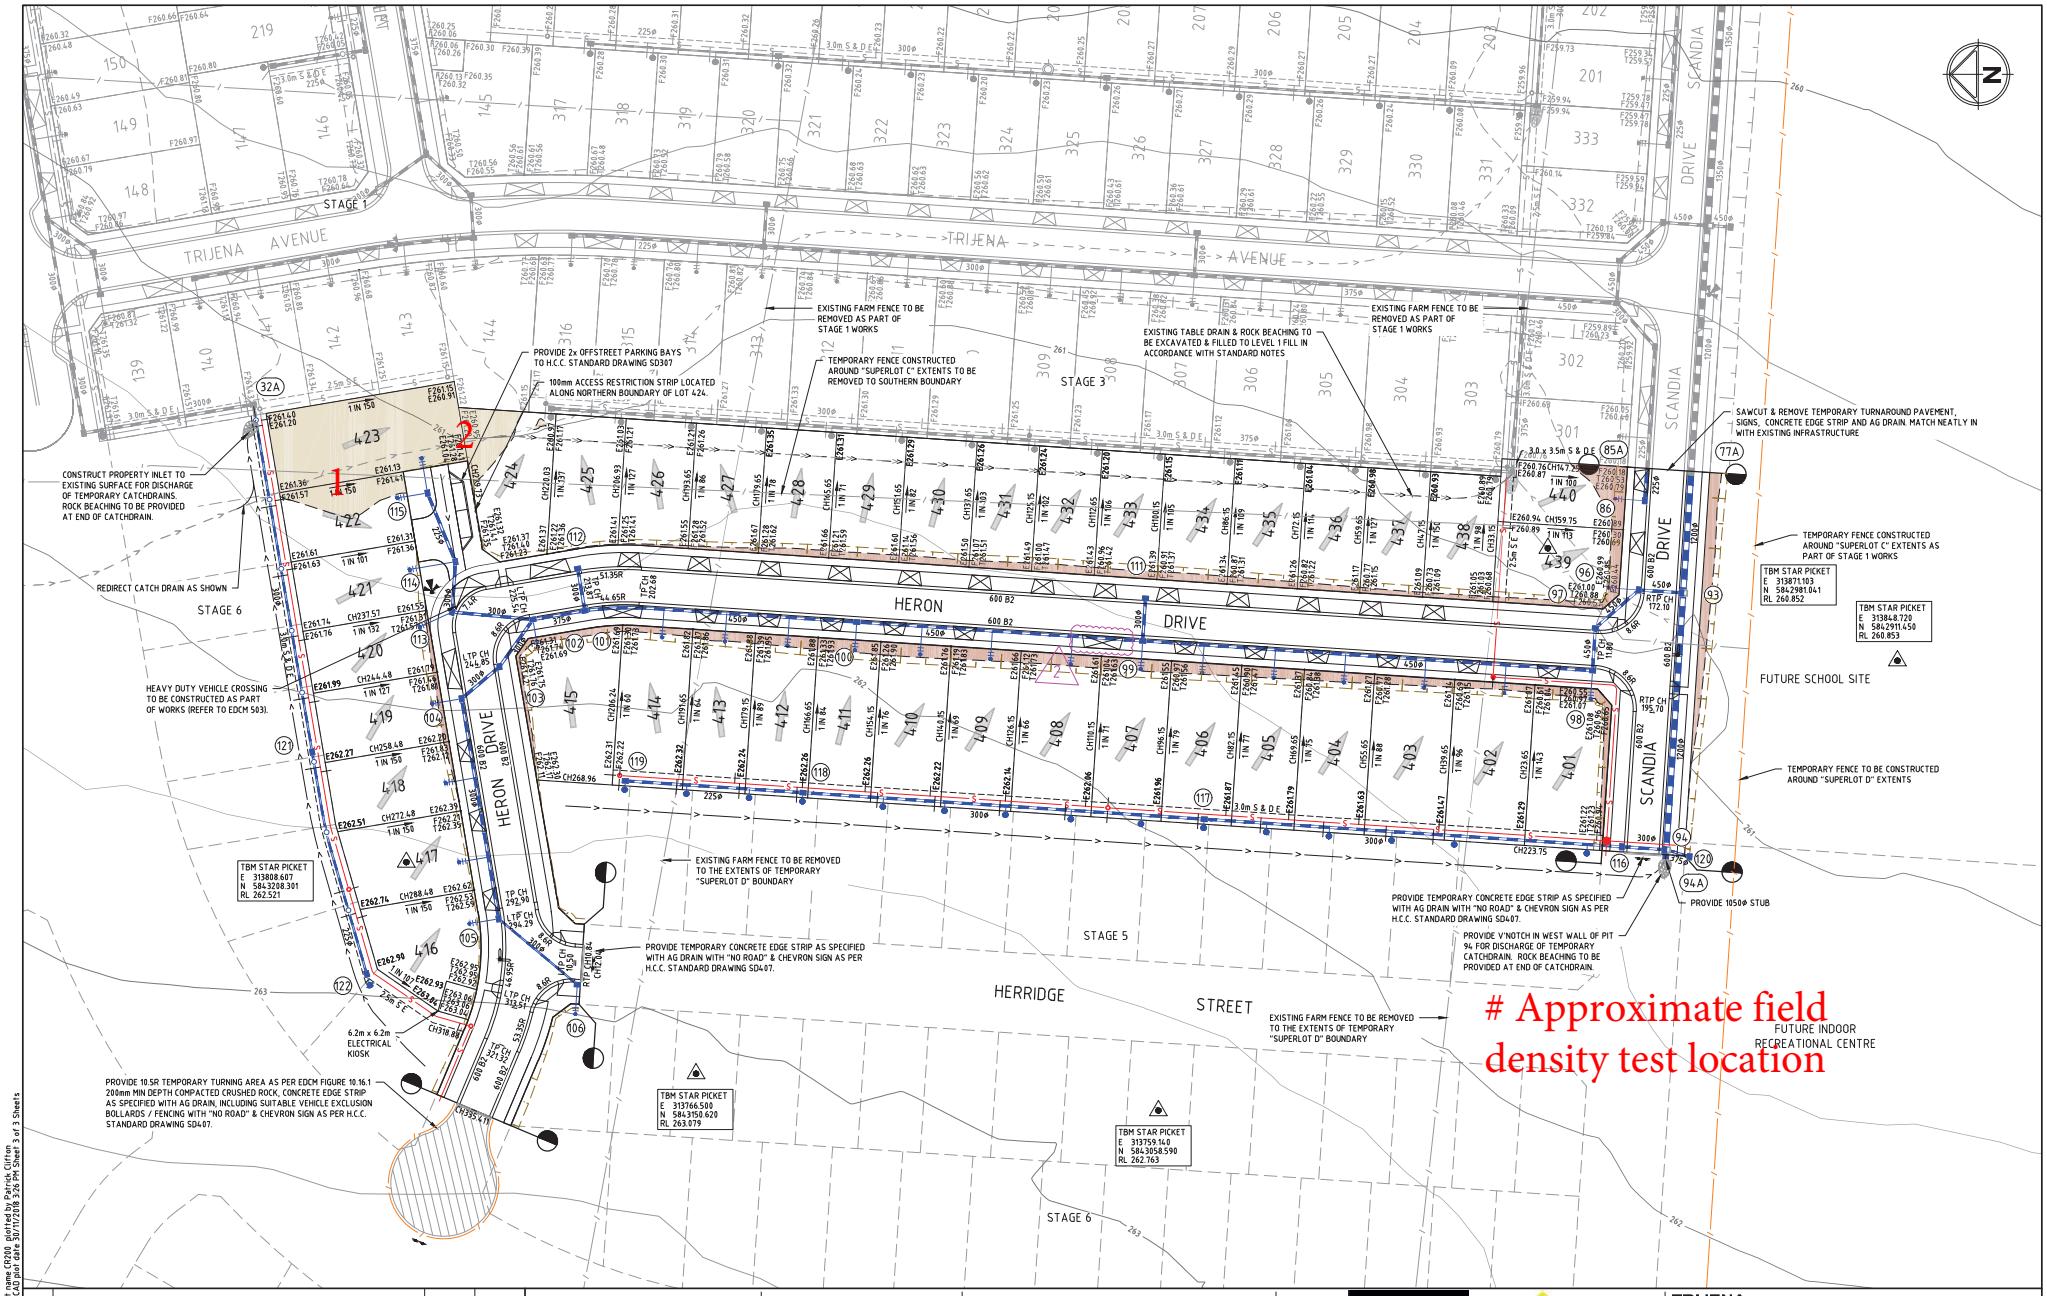
FIGURE 1

The site inspection and testing was performed by experienced geotechnicians from this office. Any areas that were deemed unsatisfactory were reworked and retested under their supervision. The testing was performed to the relevant Australian Standards and the accompanying test reports carry NATA endorsement. The attached compaction results, which were located randomly throughout the fill profile, are considered to be representative of the bulk fill materials that were placed across the reported allotments by Winslow Constructors during the aforementioned period. The approximate locations of the field density tests can be seen on the attached plan (Figure 1).
